SANDSTONE BRIDGES ON THE RIVER DIBBIN AND TRIBUTARY STREAMS

Rowan Patel

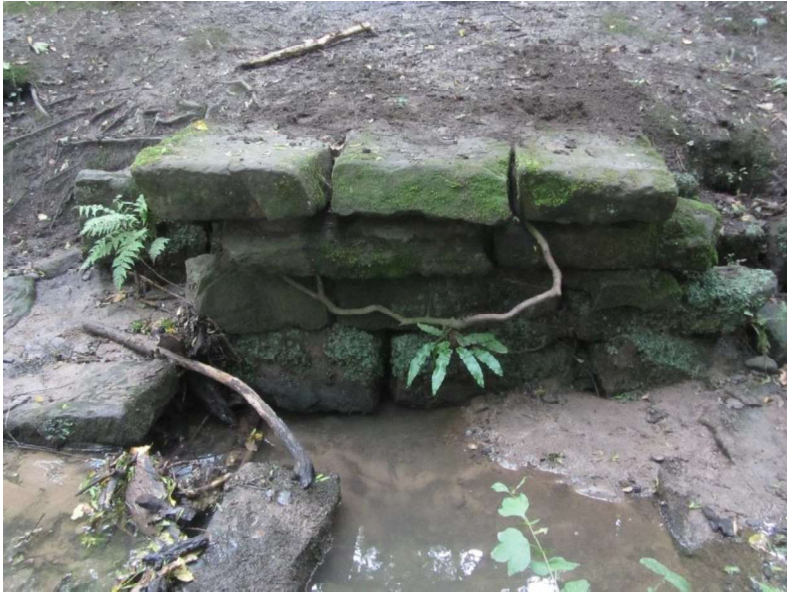
Plate VII: Bromborough clapper bridge as viewed from the bank of the stream it once crossed. The three large sandstone slabs are only wide enough to cross half of the stream. Two piers, which have now entirely disappeared, must once have supported a further row of slabs in the foreground.

This bridge is much the larger of the two clapper bridges and lies on a very minor tributary of the River Dibbin. The stream is too meagre to have a modern name, although the valley it has excavated is fairly large. It may be traced back to a point north of Cunningham Drive, where it flows beneath the railway and enters Dibbinsdale Local Nature Reserve. The earlier reaches of the stream, to the east of the railway, have now been culverted beneath an urban area. The clapper bridge, of which about half still exists, crosses the stream in its upper reaches (Plates VII and VIII).

The missing half of the bridge was presumably dismantled so as to re-use the stone. The existing remains consist of two sandstone walls forming piers and supporting three large slabs of stone. These slabs each measure approximately 60 cm (2 feet) wide, 90 cm (3 feet) long and 20 cm (8 inches) thick. The stones are fairly roughly hewn, and the entire bridge is of drystone construction, no mortar being present. The piers are formed from three courses of blocks, a typical block being 25 cm (10 inches) wide and 75 cm (2.5 feet) long. The blocks of each course are successively thicker, such that whilst the first course are only 20 cm (8 inches) thick, the bottom course of stones measure 30 cm (1 foot) in thickness. These form a very substantial foundation and are also very crudely hewn, the upper course being more accurately squared.

There must originally have been a further two piers, making four in total. There would then have been a second row of slabs to span the full width of the stream. The supporting walls continue past the three slabs which are still in position, and some displaced slabs lie in the stream. It looks as though the bridge was originally probably at

least five slabs wide, but quite possibly even six slabs wide. This corresponds to an original width of 3.5 metres (12 feet) with a total span of around 1.75 metres (6 feet).

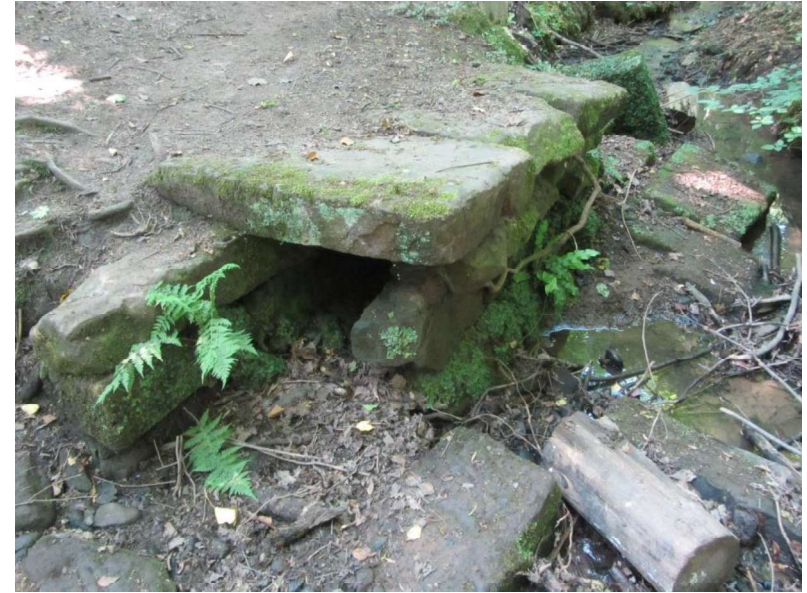
Plate VIII: The remaining section of the Bromborough bridge, as seen when looking downstream. The two sandstone piers which support the slabs are now visible. The pier in the foreground extends well past the extant slabs, showing the bridge to have once been wider. In the background some slabs which probably once formed the top of the bridge, may be seen lying out of context in the watercourse.

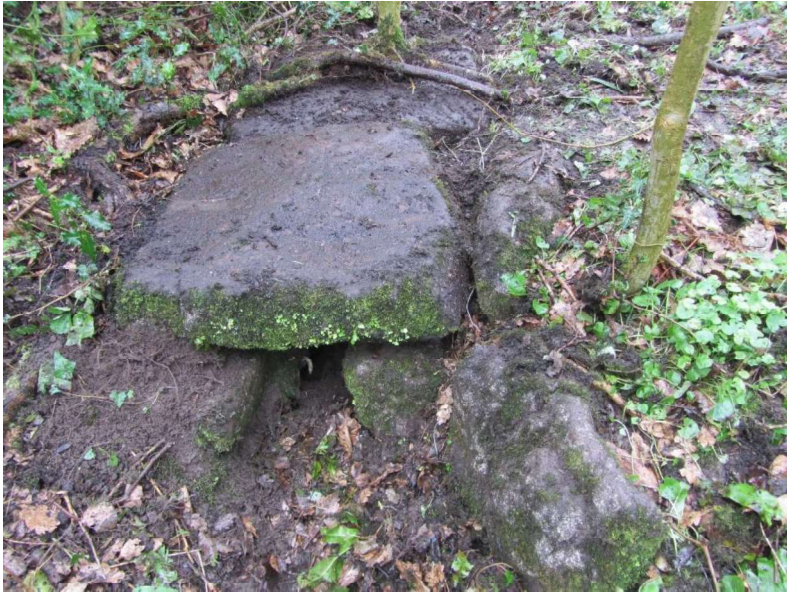
Plate IX: A front view of the Raby clapper bridge, taken looking up the ditch which it crosses. The bridge is two slabs wide, although the slab in the background is partially buried and has a tree growing upon it.

To the west of Brookhurst Avenue one of the brooks feeding the Dibbin runs through the well-wooded valley of Plymyard Dale. It is here that another clapper bridge is to be found, on the west side of the river (Plates IX and X). This area obviously has a complex history as there are township boundaries associated with Raby, Hargrave/Little Neston and Willaston along a short stretch of this western riverbank. The bridge is over a ditch/tiny tributary which acts as the boundary between Bromborough Golf Course and the lands of Hargrave House Farm. Very little water flows down here now, if indeed it was ever a natural stream. The channel is quite broad and straight, and must once have been much deeper. It may not even be natural, for it appears as if it could have been dug out to delineate a boundary.

At the far end of this ditch/stream right next to the river, is a tiny red sandstone bridge of drystone construction. This bridge is 1.2

metres (4 feet) wide with a span of 75 cm (2.5 feet). It is formed from two sandstone piers with two large slabs of sandstone resting across them. The slabs are 15 cm (6 inches) in thickness and measure approximately 60 cm (2 feet) by 75 cm (2.5 feet). The piers continue past the two slabs, hence it appears that the bridge may once have been three slabs wide. In some ways this structure is more curious than the bridge in Bromborough, which at least crosses a gully of sorts. This ditch is extremely insignificant at the point the bridge crosses it, much more so than the stream at Bromborough. A single slab's width would be quite adequate for a person to cross, so the fact the bridge is multiple slabs wide, may again suggest use by animals.

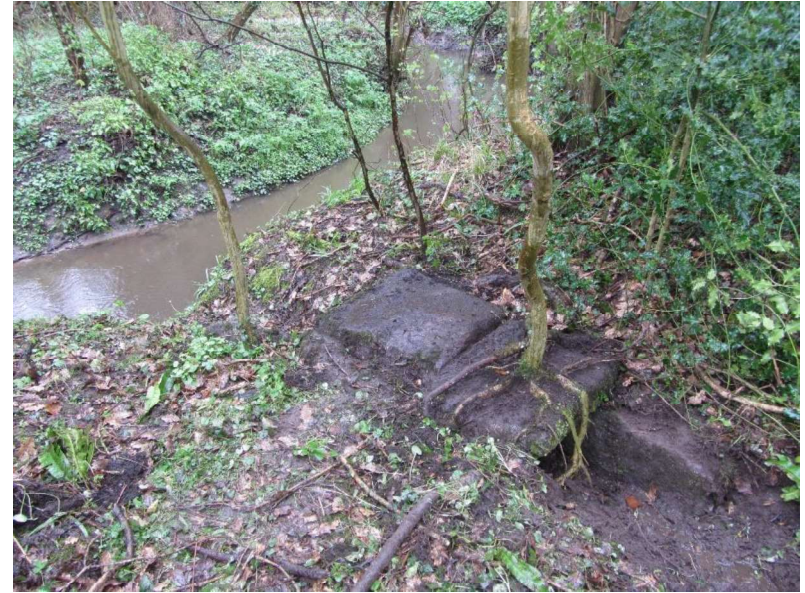
Plate X: Raby clapper bridge as seen when looking across the ditch. At the right-hand end, one of the piers may be seen protruding from beneath the slab it supports. The bridge lies in very close proximity to the river.

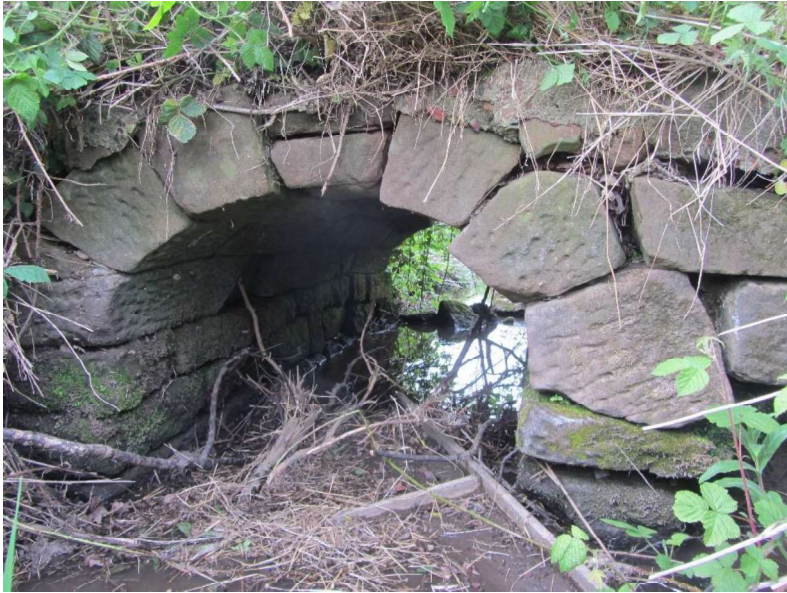
Plate XI: This is the third arched bridge to the south of Hooton Road. It is also the first intact example, for only a few courses of stone remain of both the previous bridges. The stonework inside the arch fits together beautifully and is very well-dressed.

These bridges gave access between the fields on either side of the stream, and remarkably there are traces of four bridges crossing a section of river scarcely a quarter-mile long. Moving south from Hooton Road, the first two bridges are completely ruined, with only a few courses of stonework left on the riverbank. Of both bridges there are five courses left on the eastern bank, around 1.5 metres (5 feet) in length. A modern bridge formed from wooden planks still does service at the site of the second bridge, and the remains of the earlier structure are hidden beneath. Fortunately we know how these two bridges must have looked originally, since the third and fourth structures are complete (Plates XI and XII).

These bridges are very substantial and well built, both being constructed to the same design. In each case it has taken some 12 courses of stonework to form the arch which spans the banks of the stream. The span of both bridges is 2.75 metres (9 feet) and the internal diameter of the arch is 90 cm (3 feet), with a wall thickness of 90 cm (3 feet). The only major difference between the bridges is their width, the third bridge south of Hooton Road being 2.5 metres (8 feet) wide, whilst the fourth bridge is 3 metres (10 feet) wide. These are the original widths, for the bridges appear to be as constructed, with no evidence of any later modifications. There are traces of mortar binding the stones, although this is fairly minimal and some of it appears to be modern. It does appear however, that these were built as mortared structures, rather than being drystone as in the case of the clapper bridges. The width of the bridges also makes them more than simple footbridges. They must therefore have been built to cater for the movement of livestock and agricultural implements.

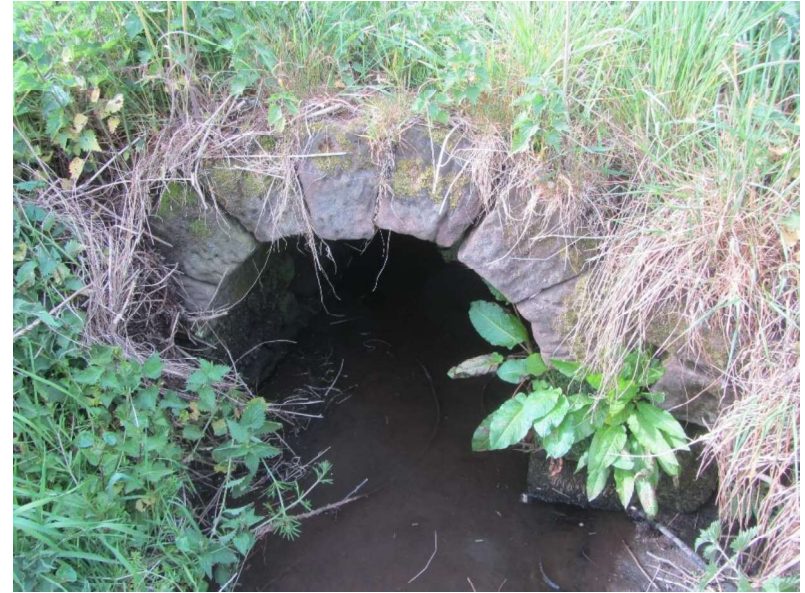
Plate XII: The fourth bridge to the south of Hooton Road in Childer Thornton. Its design is identical to the previous bridge. The arch is three feet across, which gives some indication of the narrow width of the brook it crosses.
